Clara Barton National Historic Site

Historic Structure Report

Part: 1
Physical History /Condition Assessment

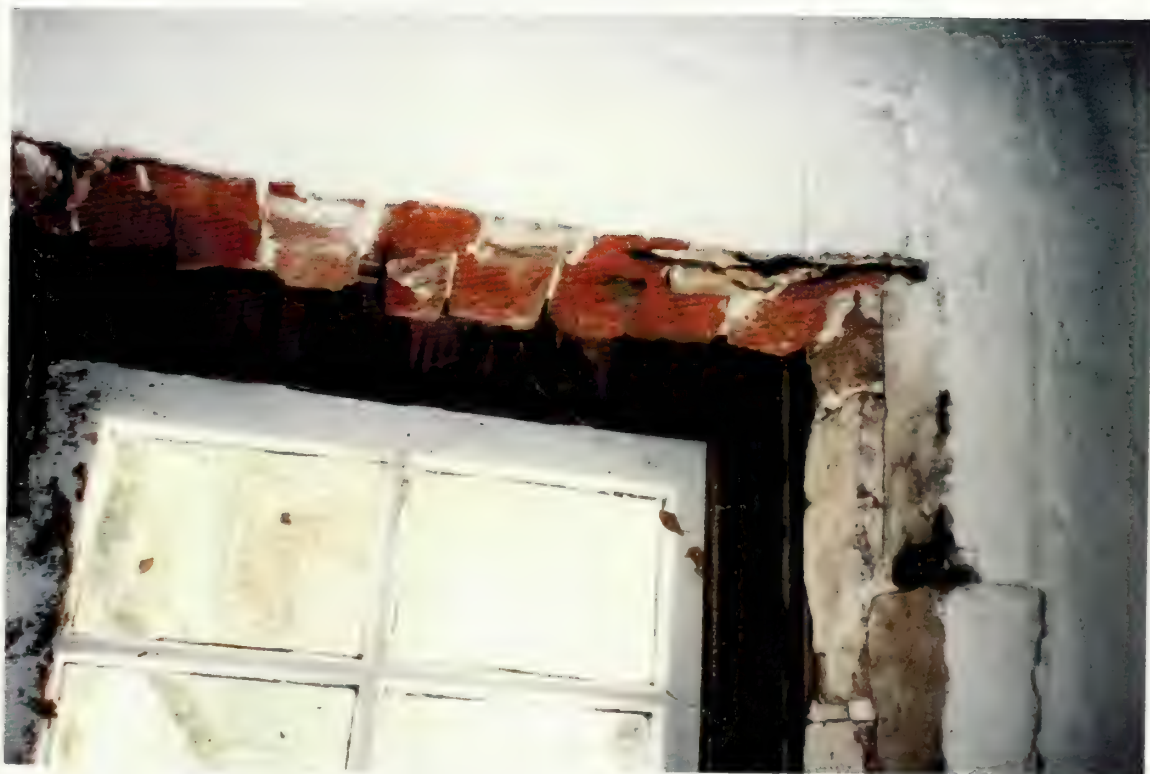
Figure 21: Close-up view of the vault window showing the rough edge on the left where the bricks were broken out to crate the opening. Also note that there is no lintel across the top of the opening and that the brick to the extreme right is loose and ready to fall.

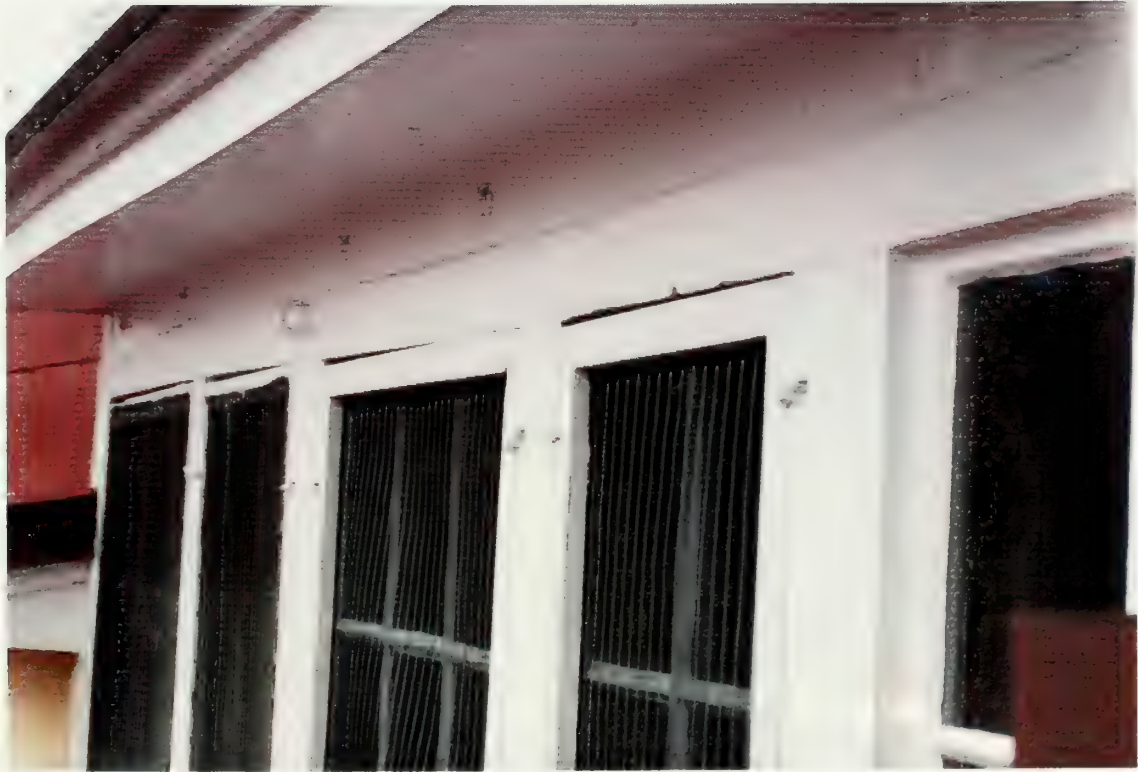
Figure 88: View, looking east, at the northwest wall of Room 301 showing how the header above the windows is sagging.

Structural Recommendations: Except for the inadequate load bearing capacity of the floor structure (which can to a large extent be managed programmatically), the only structural recommendation is the replacement of the header on the first floor beneath the stairs.

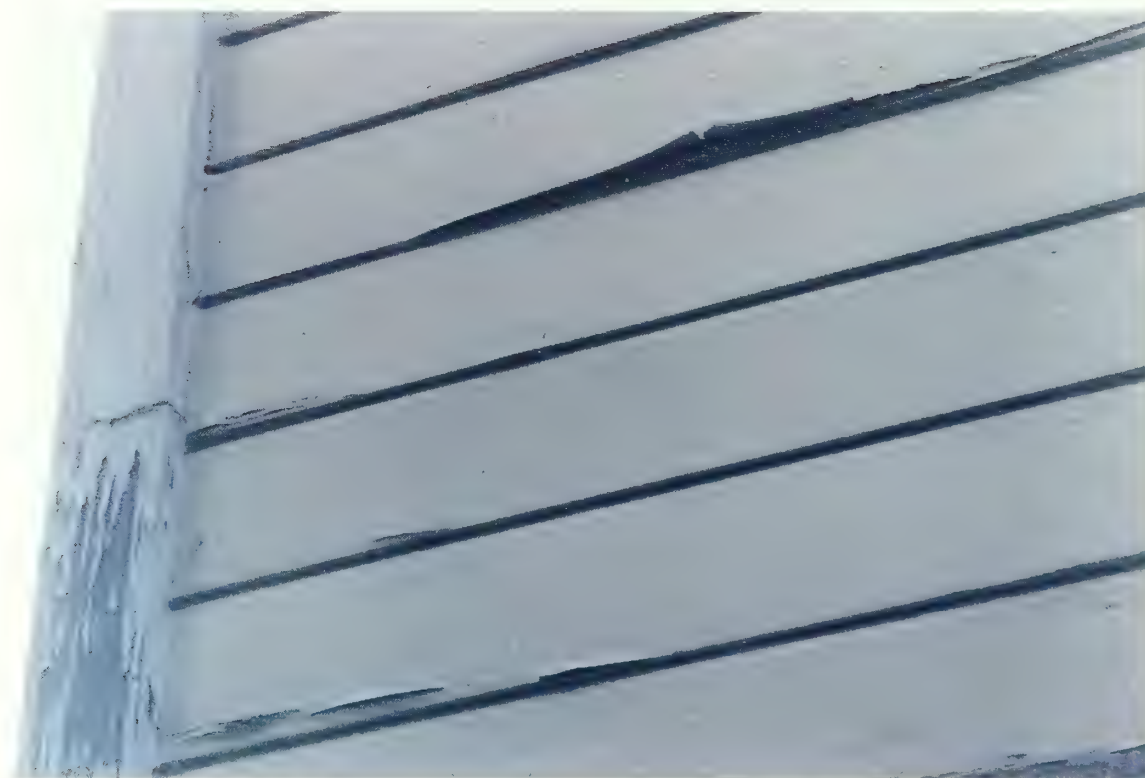
Figure 94: Close-up view of replacement German siding on the southwest elevation. Notice the peeling paint.

On the exterior of the building, regular maintenance should be increased. Much of the paint is deteriorated and this has allowed some of the wood trim and siding to begin to deteriorate. Two paint related problems appear to be inadequate surface preparation, which causes the paint to peel and flake off, and mildew, which also breaks down the paint. Mildew can be reduced or eliminated through the addition of a mildewcide to the paint.

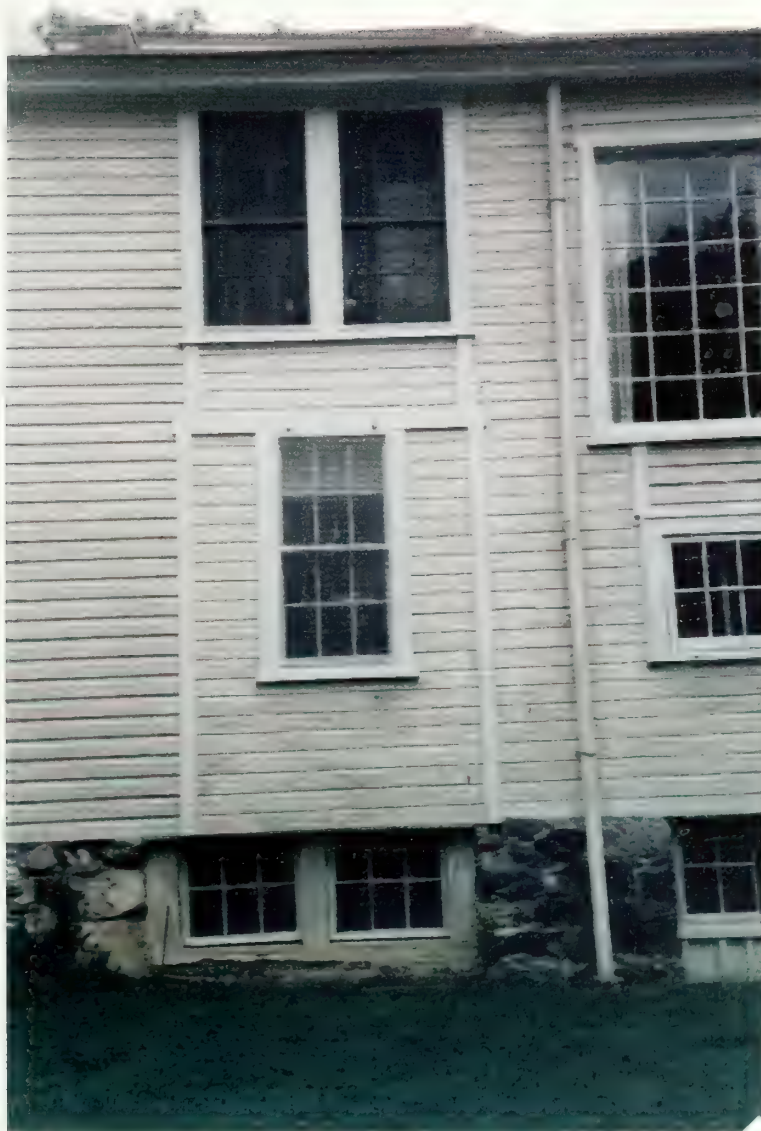
Figure 95: General view of the siding on the northwest elevation. The dark splotches are areas that have mildewed.

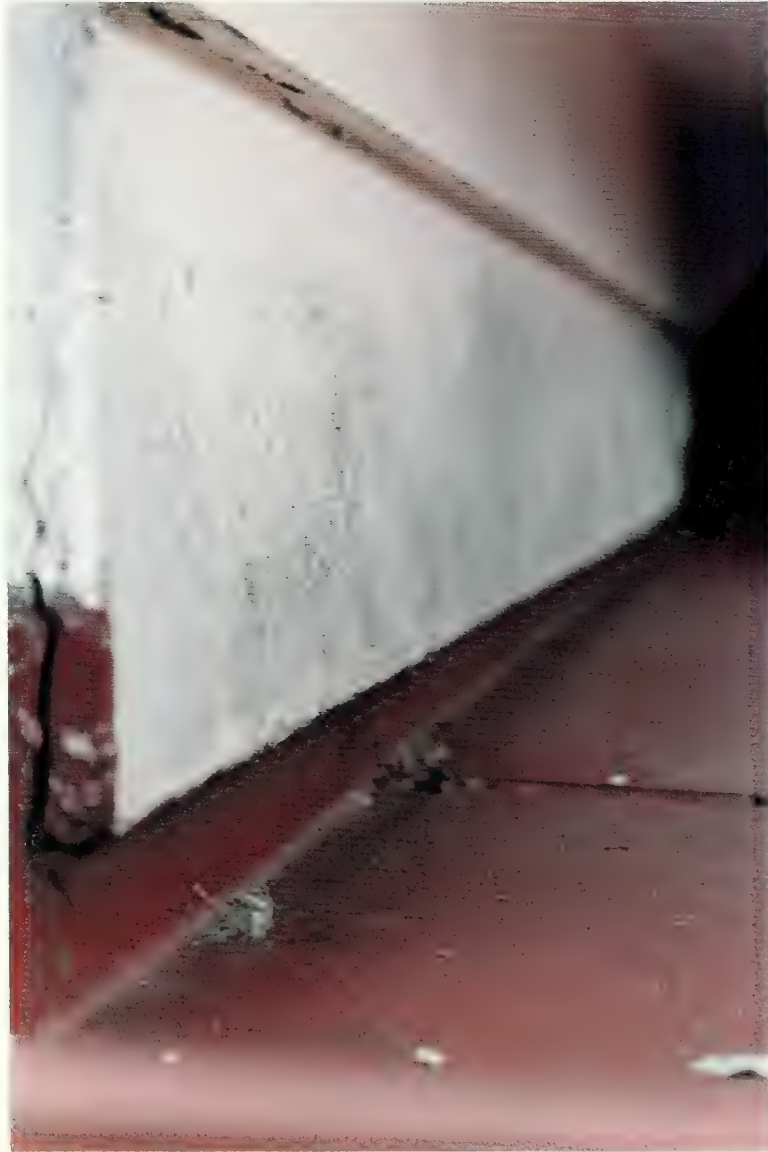
Figure 96: *Close-up view of the lap siding on the northeast elevation of room 301. The exposed endgrain of the siding deteriorating and this board has split..*

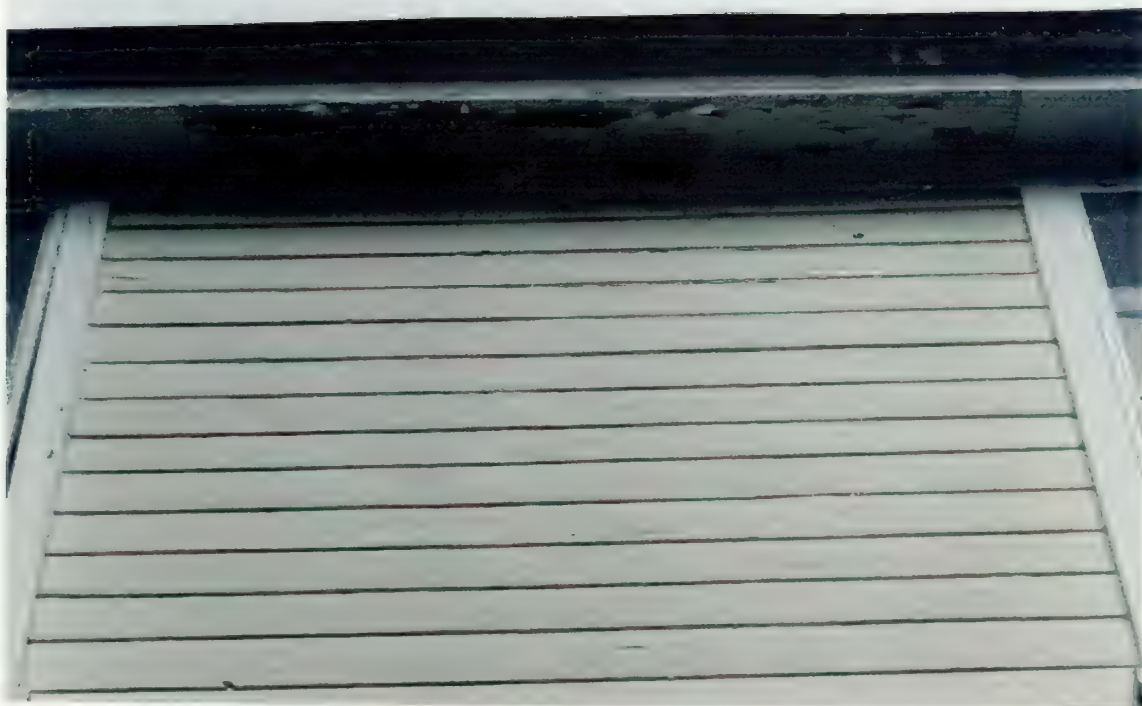
Figure 97: *Section of the soffit on the southeast elevation of the house showing where water penetration from gutter leaks is causing the paint to peel.*

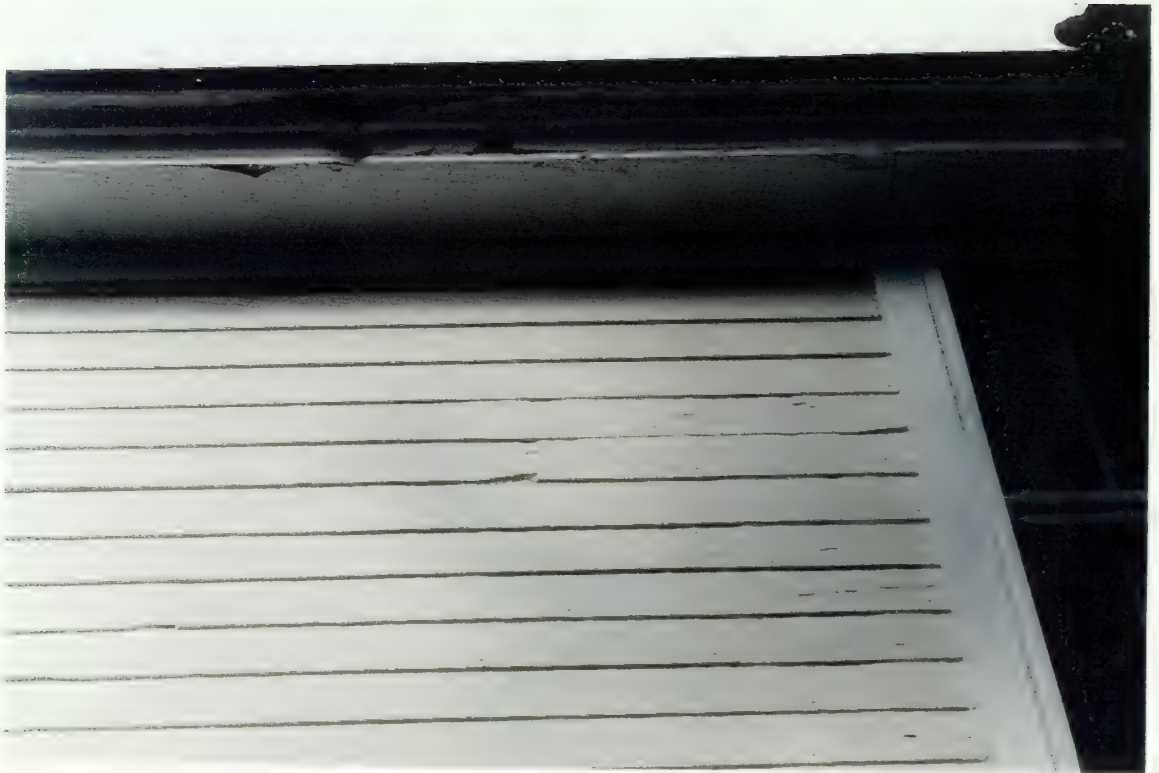
Figure 98: *Section of the soffit on the southeast elevation of the house showing where water penetration from gutter leaks has caused a section of the soffit to rot through.*

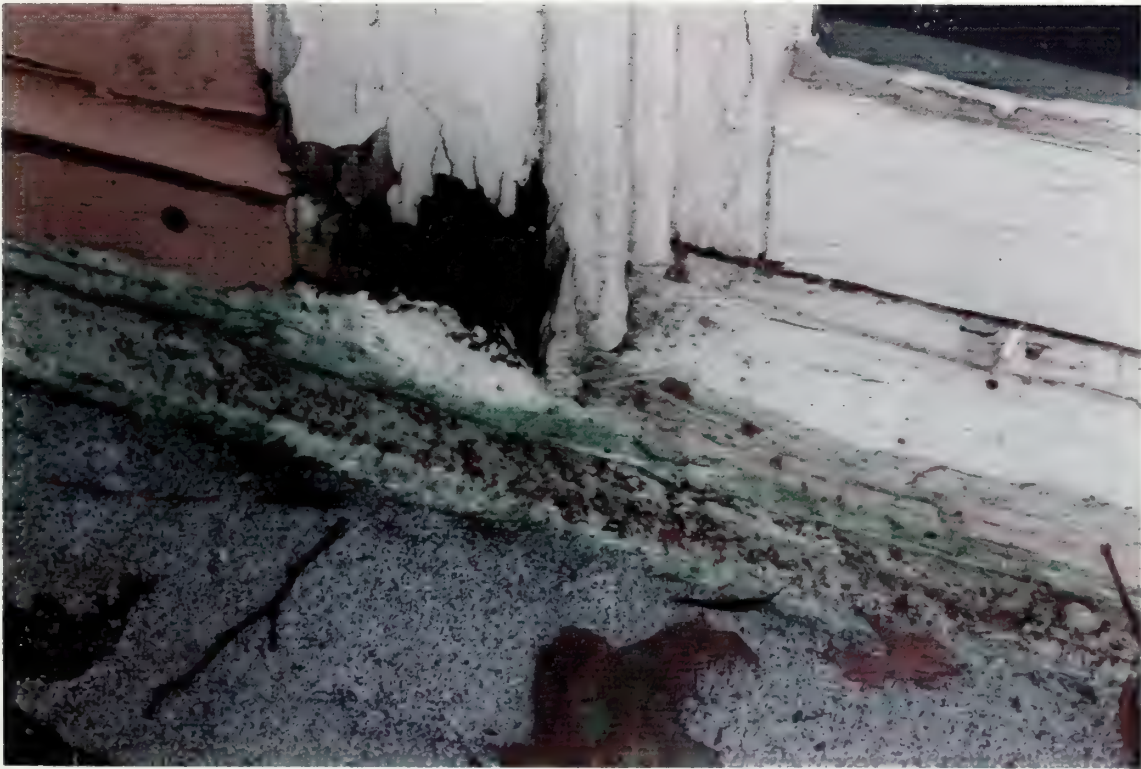
Figure 99: Close-up view of a second floor window sill at the front porch roof. Because the roof deck is level with the sills, there is no room for flashing causing the window sills and trim, and adjacent siding to deteriorate. Here, the trim visible at the top left of the photo has been replaced and the window surround is in particularly bad condition.

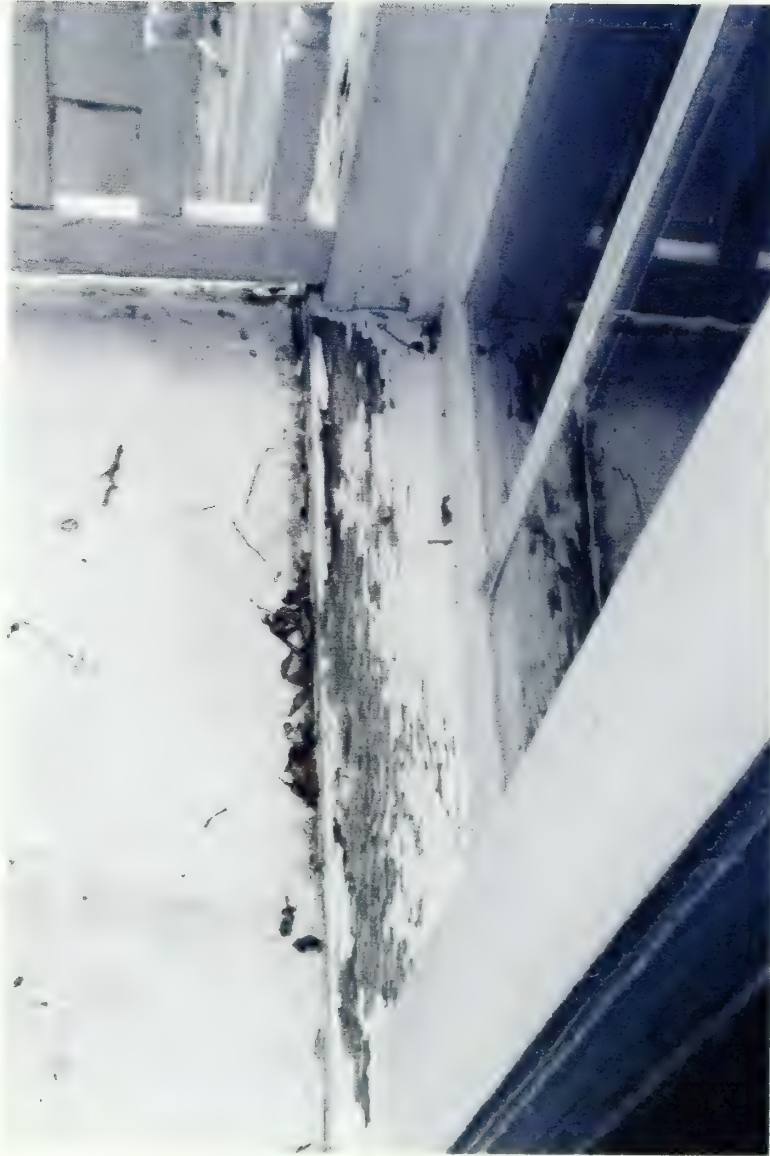
Figure 100: View looking down on the sill of a second floor window at the front porch roof. Because the roof deck is level with the sills, there is no room for flashing causing the window sills and trim, and adjacent siding to deteriorate. This view shows a weathered sill badly in need of repainting.

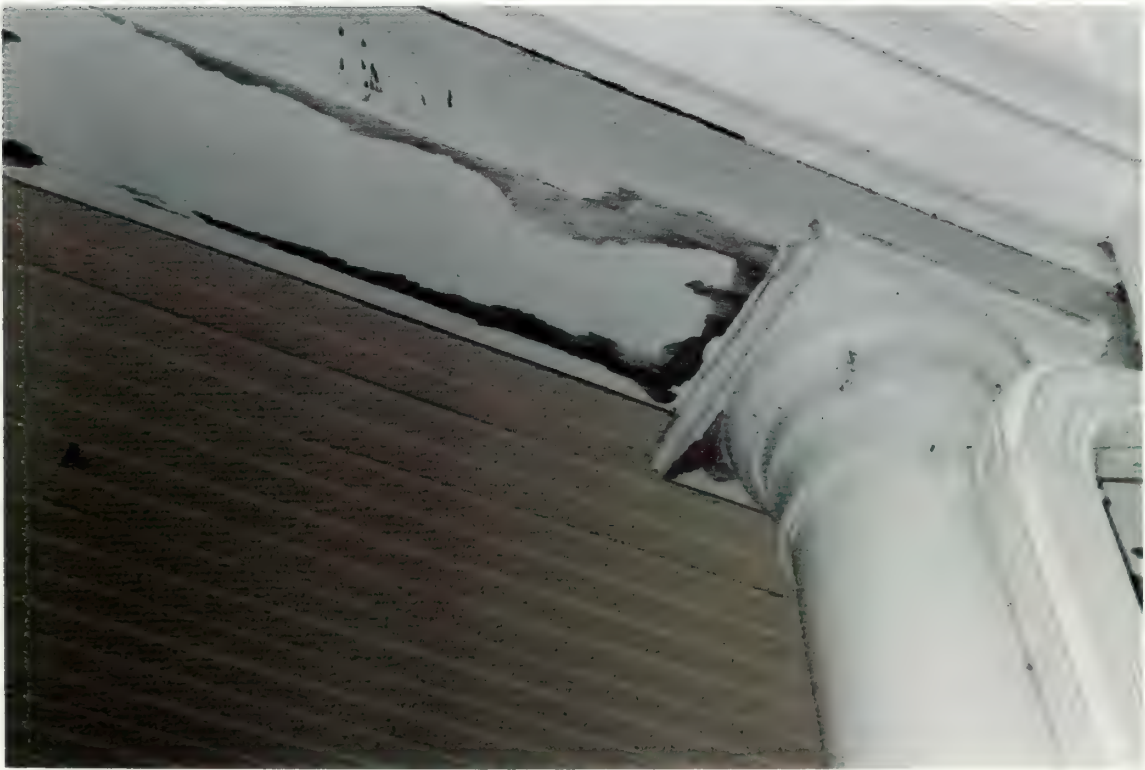
Figure 101: View looking up at the top of a front porch column showing evidence of water penetrating down through the porch roof.

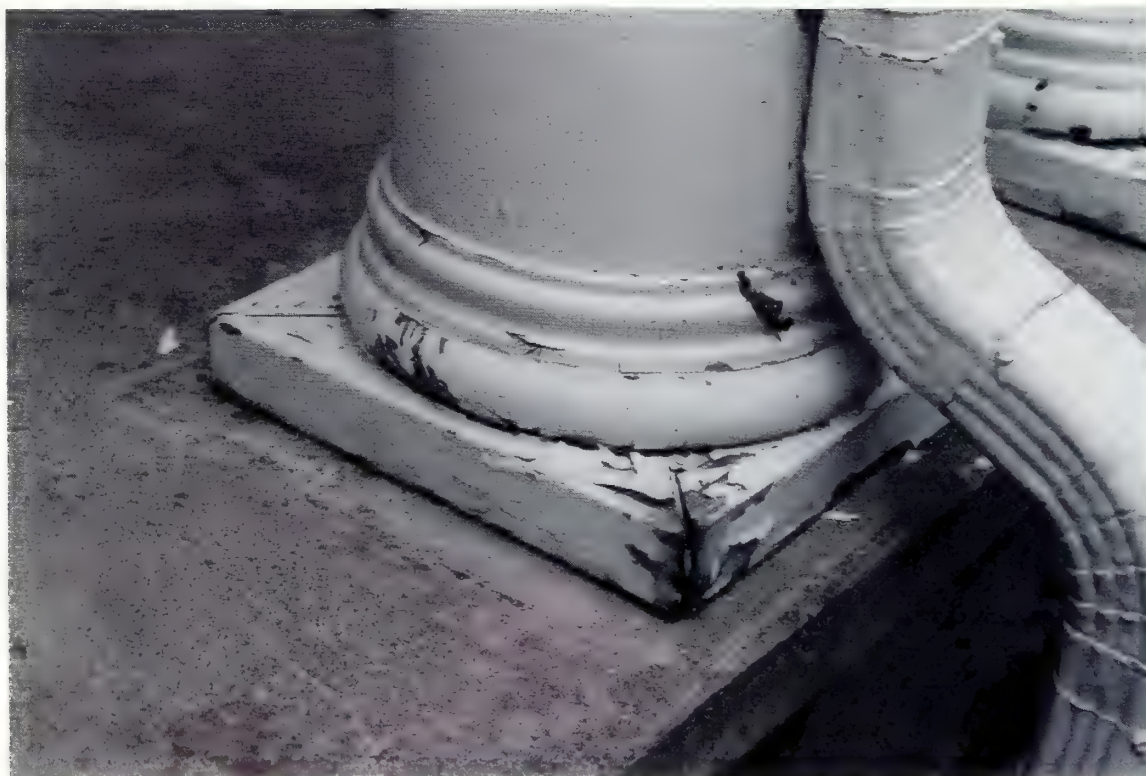
Figure 102: View showing the base of a front porch column showing evidence of water damage.

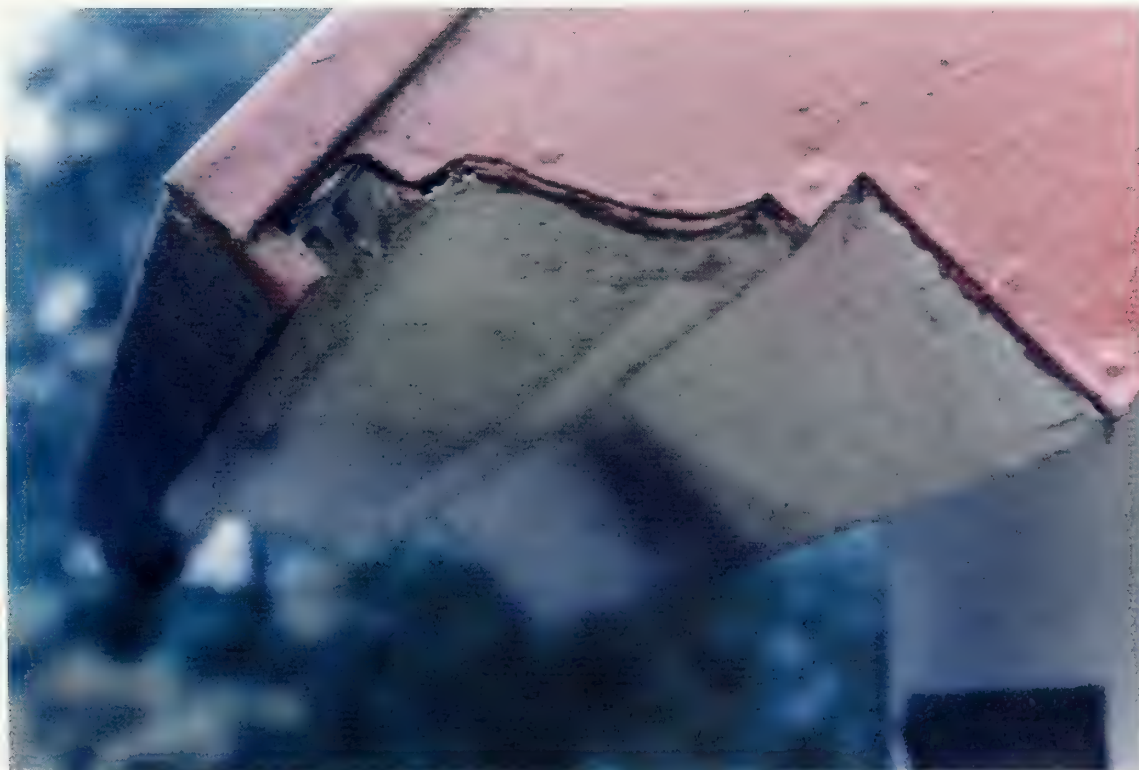
Figure 103: View showing the end of the front gable molding. Although the ends of the trim have been covered with metal flashing, the endgrain of some of the wood is beginning to deteriorate.

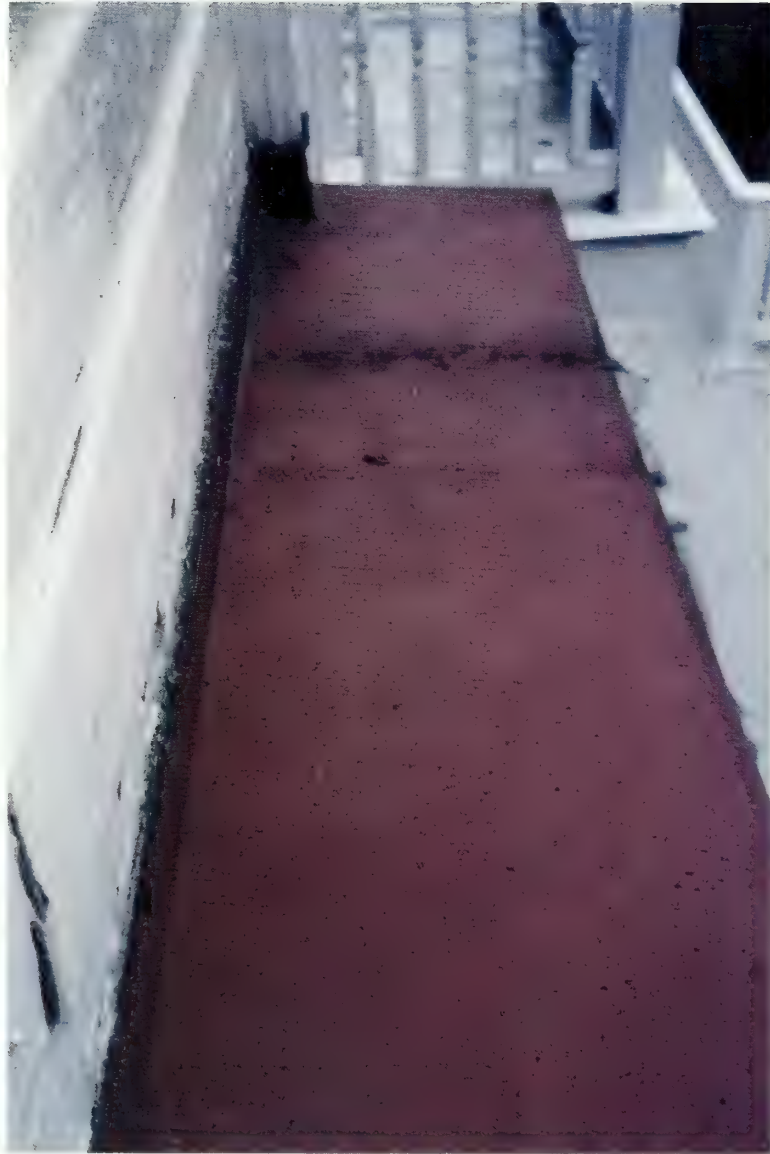
Figure 104: View, looking northwest along the front elevation, showing how the parapet roofing is turned up at the wall without any counter flashing. The metal roofing actually turns out, away from the wall, at the top creating a "funnel". This funnel is filled with sealant, however, the sealant if failing and will allow water to be channeled behind the flashing.

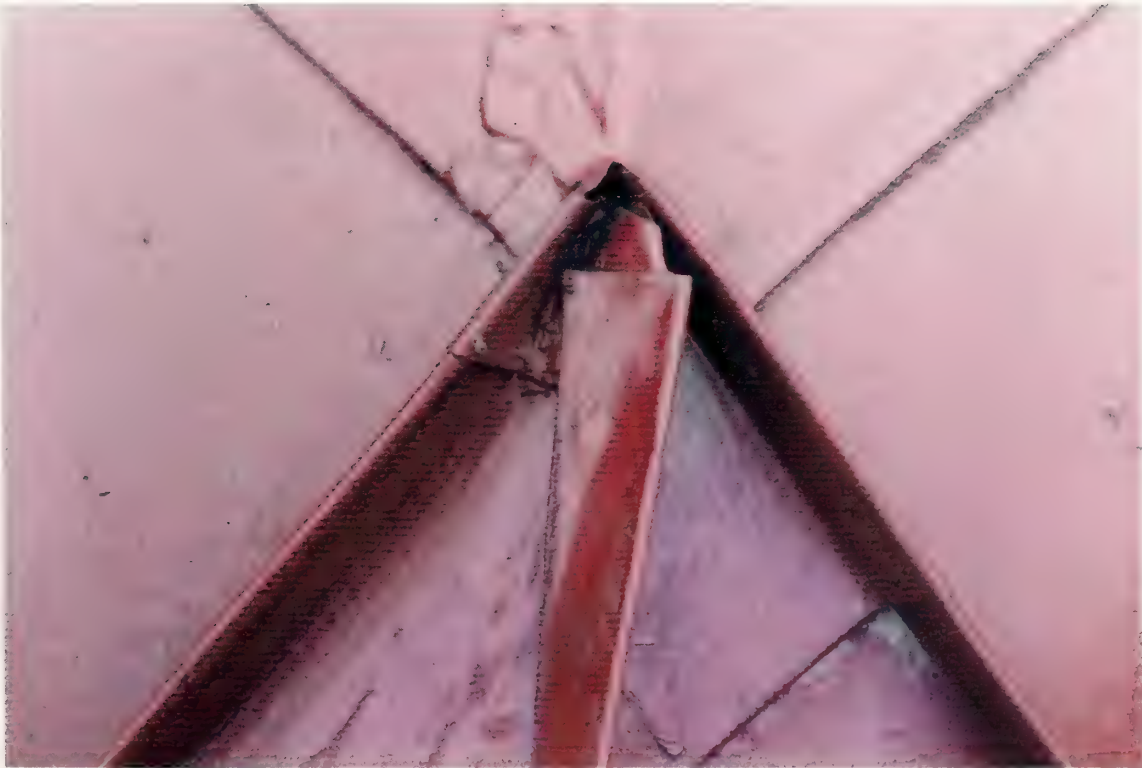
Figure 105: *Roof detail showing where two pan seams meet a hip seam. The junction of the three seams does not appear to be sealed and may admit water.*

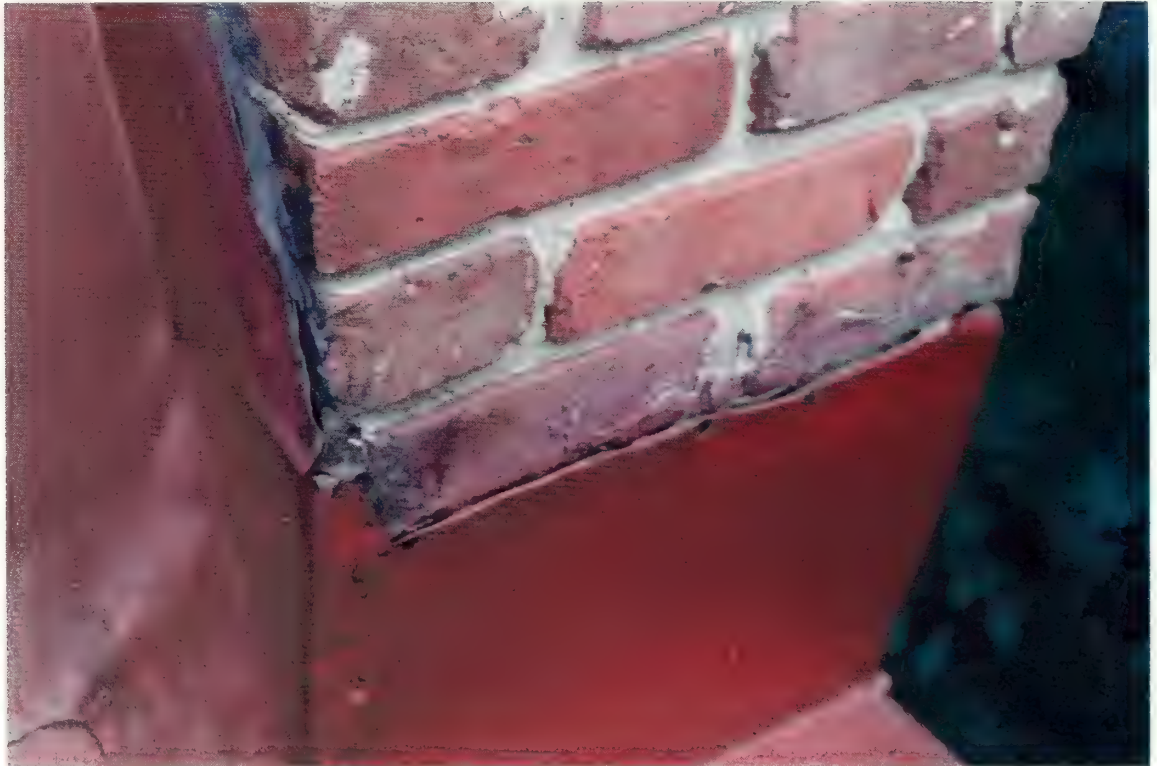
Figure 106: Close-up view of the flashing at one chimney showing how the lack of an adequate seal could allow for water to gain access behind the flashing. similar conditions exist at other chimneys.

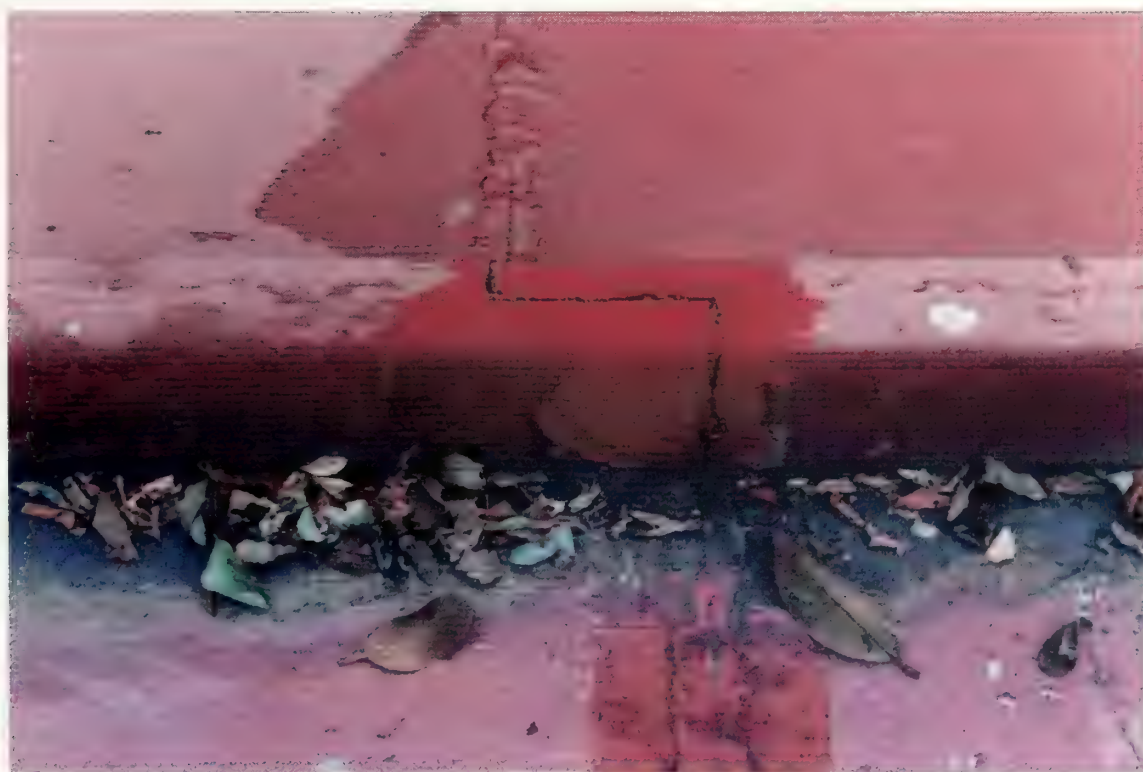
Figure 107: Close-up view of a soldered seam in the flat roofing at the diverter showing how the lack of expansions joints has caused the joint to fail.

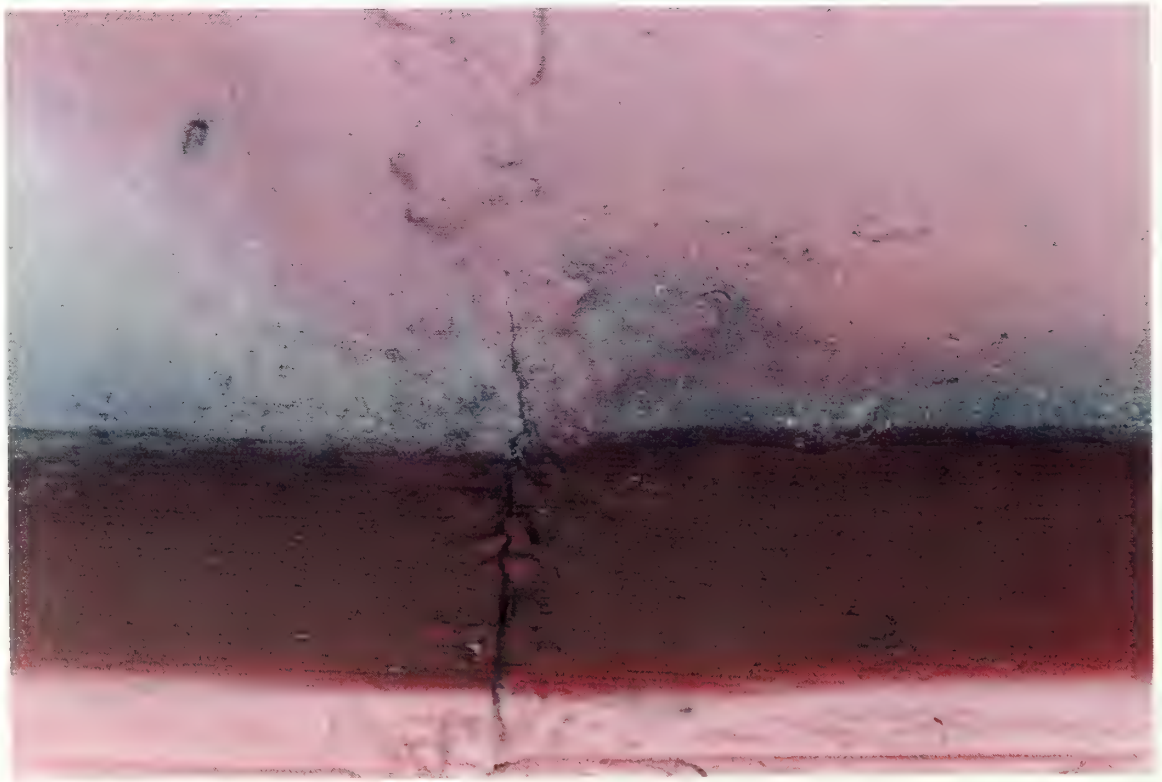
Figure 108: Close-up view of a soldered seam in the flat roofing at the diverter showing how the lack of expansions joints has caused the joint to fail.

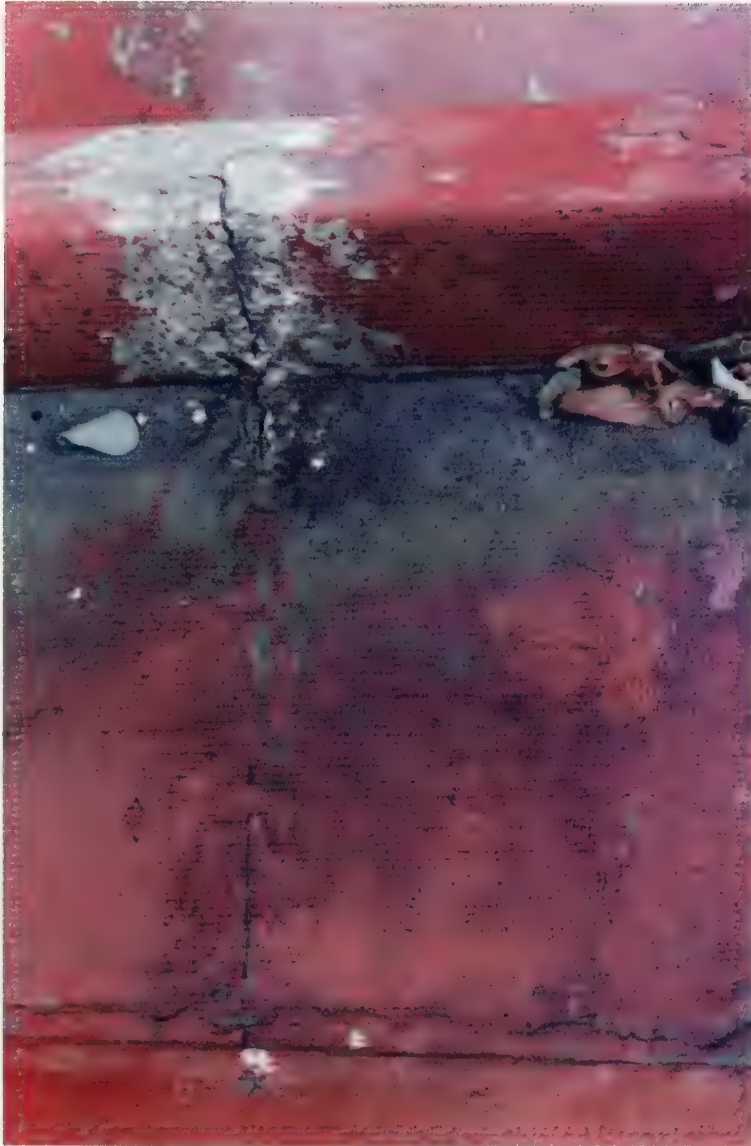
Figure 109: Close-up view of a soldered seam in the flat roofing at the diverter showing how the lack of expansions joints has caused the joint to fail. It appears that an attempt has been made to resolder this joint. Notice that this joint has failed not only at the diverter but also adjacent to the joint with the standing seam roofing. The soldered joint between the flat and standing seam roofing, visible at the bottom of this photo, is typically in good condition.

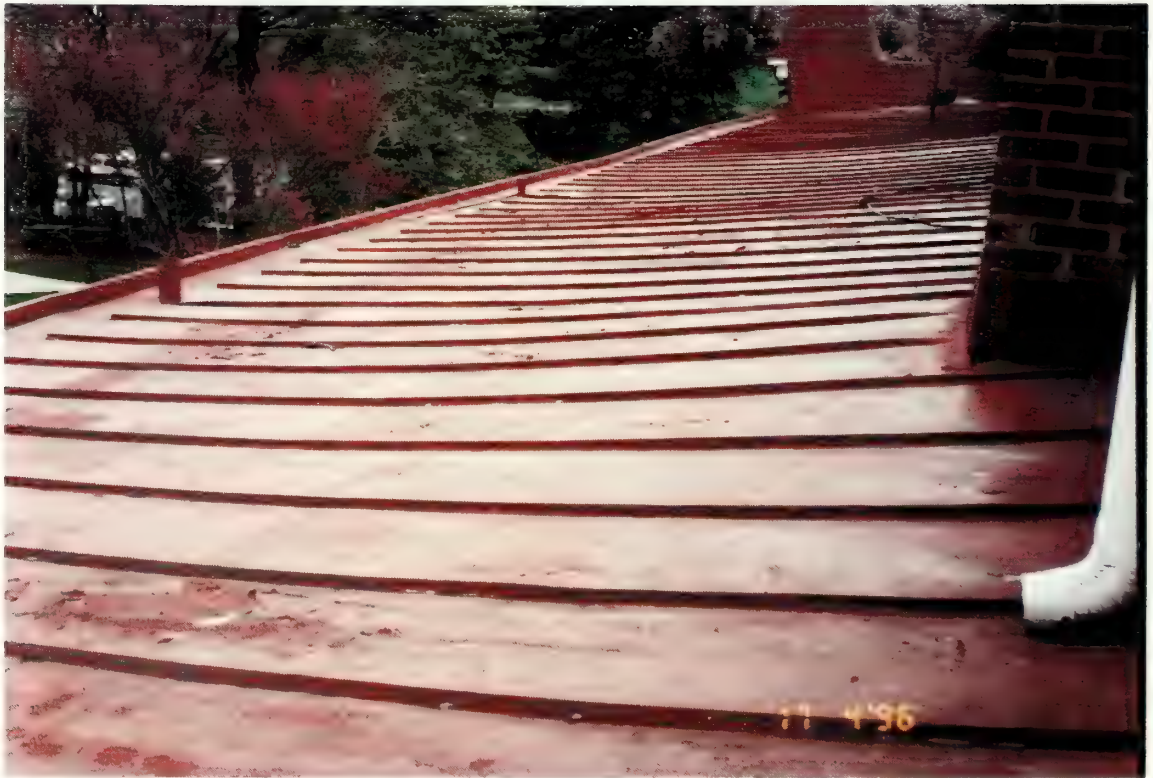
Figure 110: View looking northeast along the second floor roof of the northwest wing of the Clara Barton House. Notice the bow in the rafters. Also notice how the standing seam roof terminates to the right of the diverters.

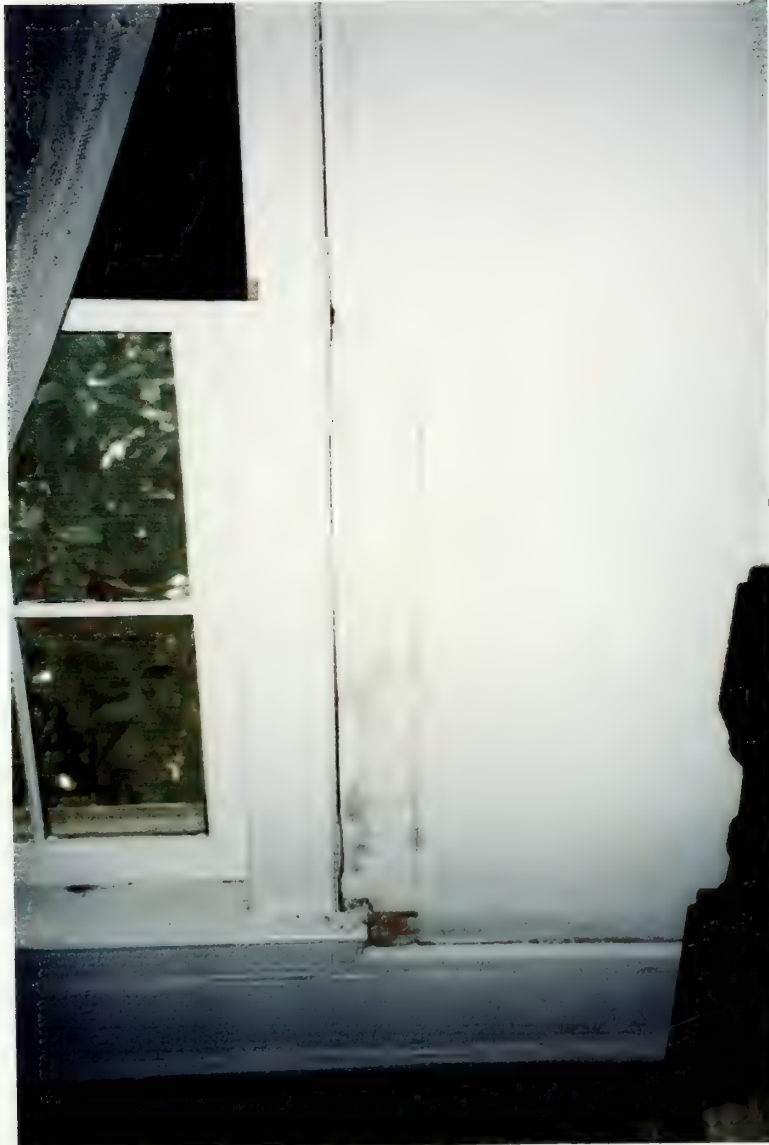
Figure 111: Close-up of the area adjacent to one of the windows in room 215. The roof above this room has been leaking and water damage such as this is visible along this wall and in the ceiling above.

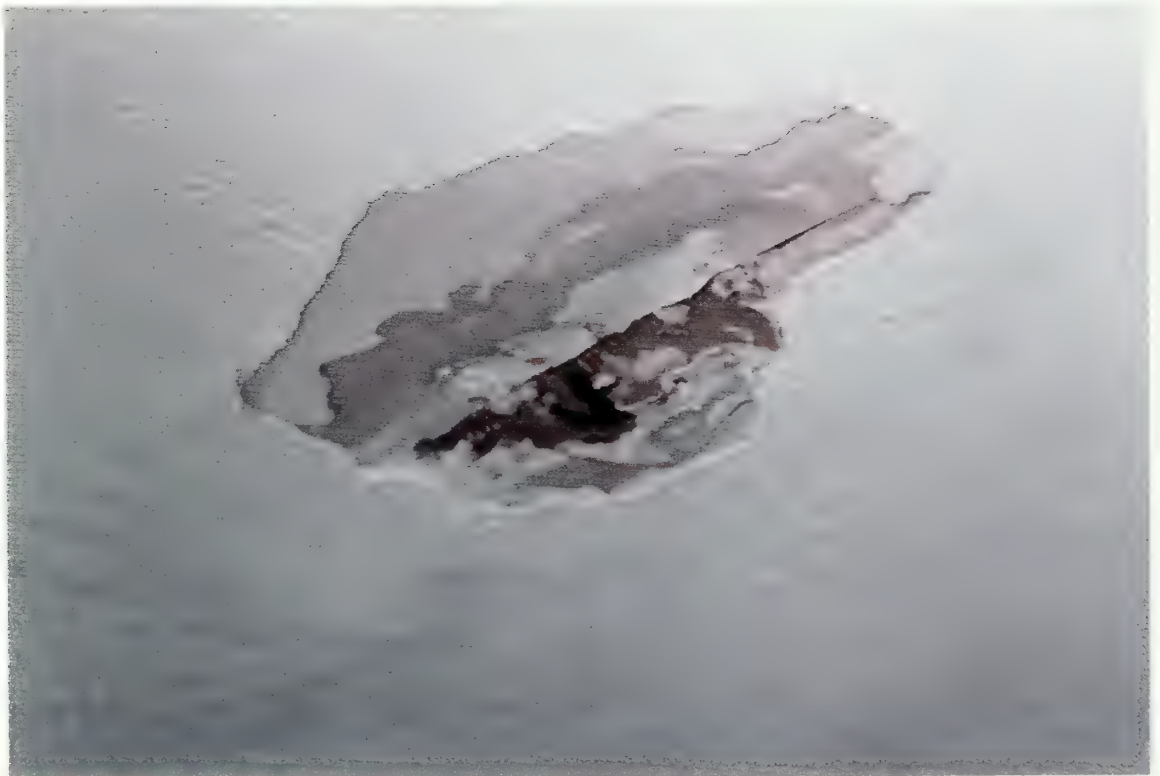
Figure 112: Close-up of the ceiling in room 201. During the summer of 1996, water damage was first noticed in this area of the ceiling. Although no source for the leak is immediately apparent, the volume of water entering here has been sufficient to open a hole in the gypsum board ceiling.

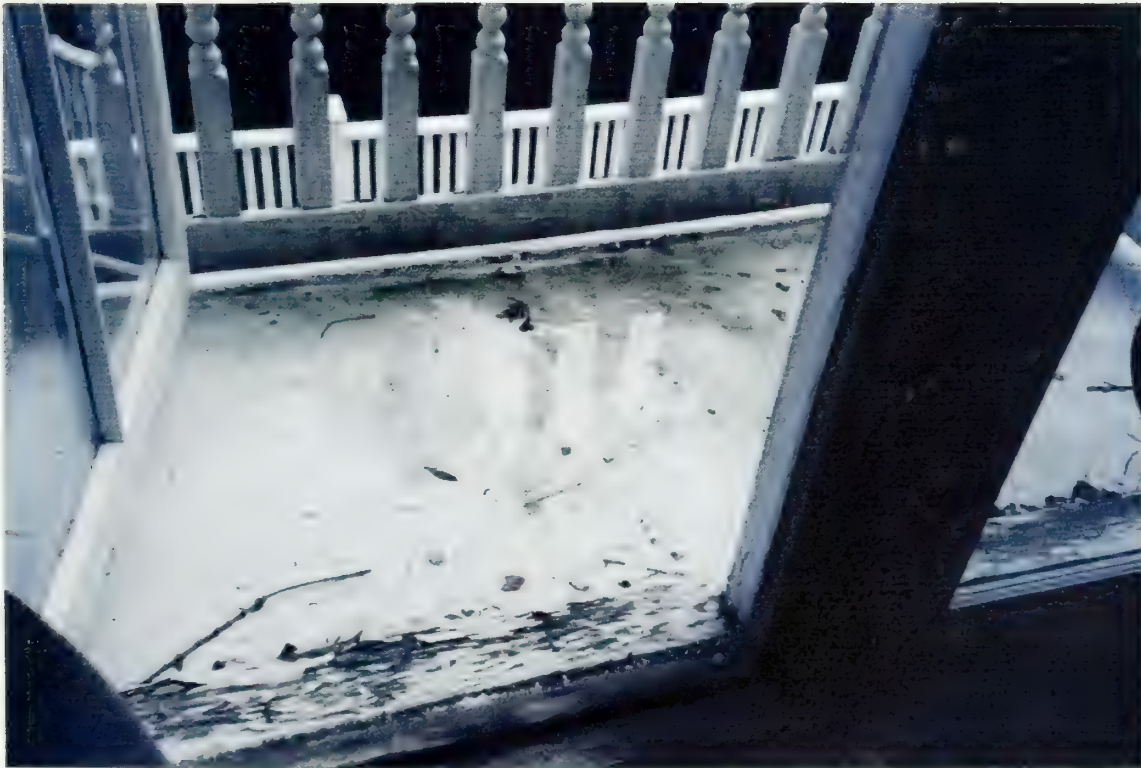
Figure 113: *View of the balcony on the third floor of the front elevation. Despite the fact that a small amount of water is pooling on the balcony, there is no apparent source for the leak that has damaged the ceiling of the room below.*

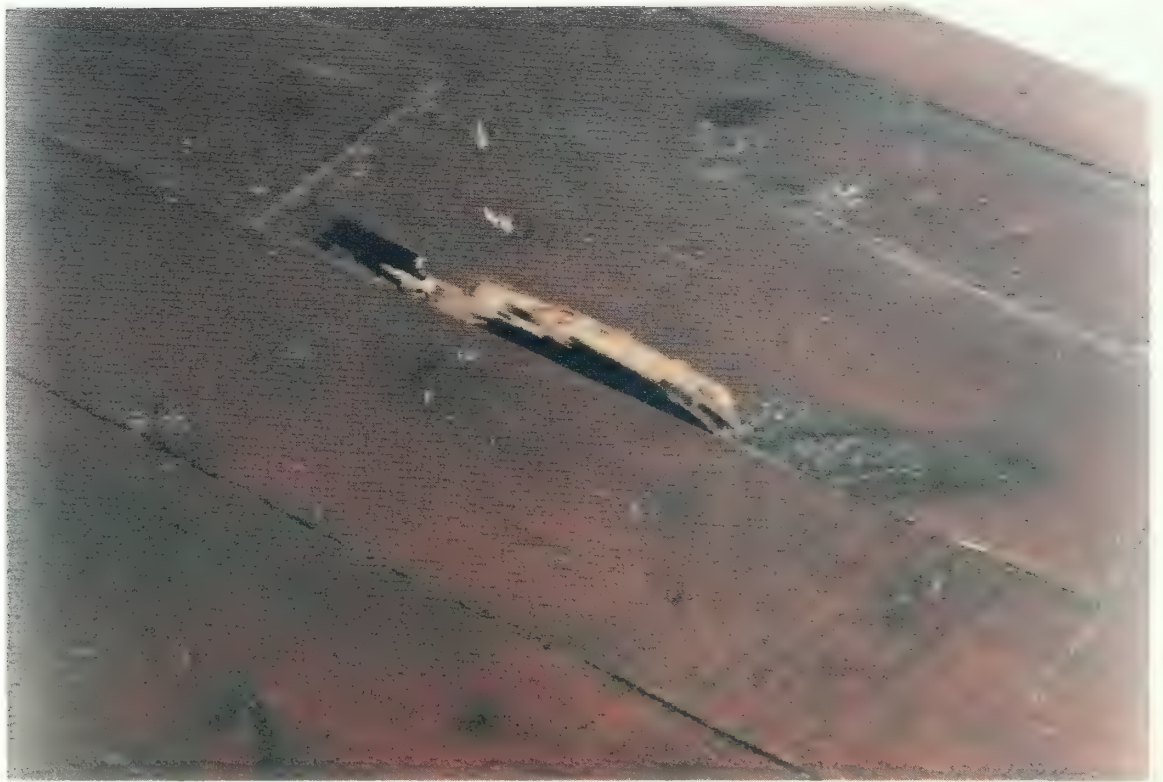
Figure 114: Close-up view of insect damage to the floor in room 218.
